# Sunrooms

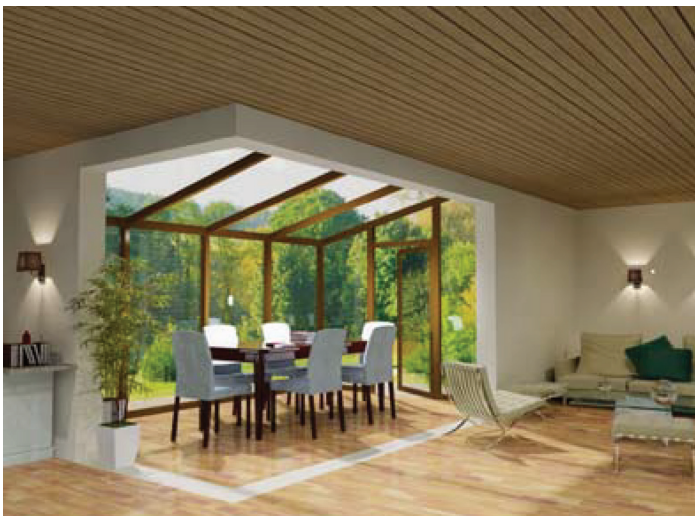
**Glass roof leaks:** The joints between the glass panels are a vulnerability. It is a common leakage point, particularly on older sunrooms. Gasket material may stiffen and break down over the years or pressure clamps may become loose resulting in leakage. Caulking is usually a sign that there has been trouble.

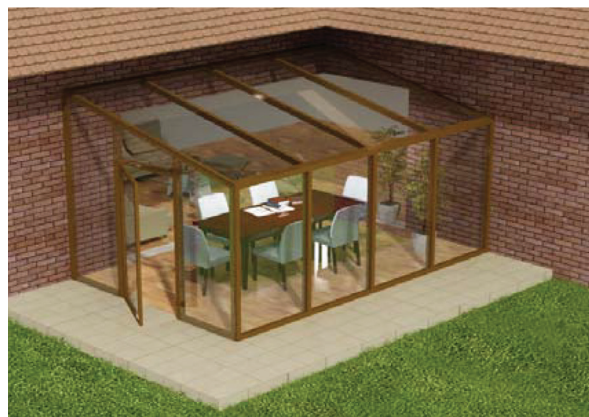
In many cases, the sunroom gets built directly on the deck and consequently the deck foundation. It is not uncommon for Pillar To Post inspectors to discover a support structure that is not ideal. While liberties may have been taken for a deck, we expect more from an enclosed structure that becomes part of the home. The foundations may simply not have been designed with this end use in mind. This can cause problems such as cracking of the glass or flashings and seals pulling apart and leaking due to movement of the structure.
